# McCormick and Baxter Creosoting Co. Superfund Site

## Portland, Oregon

# Supplemental

# SITEWIDE RECORD DRAWING

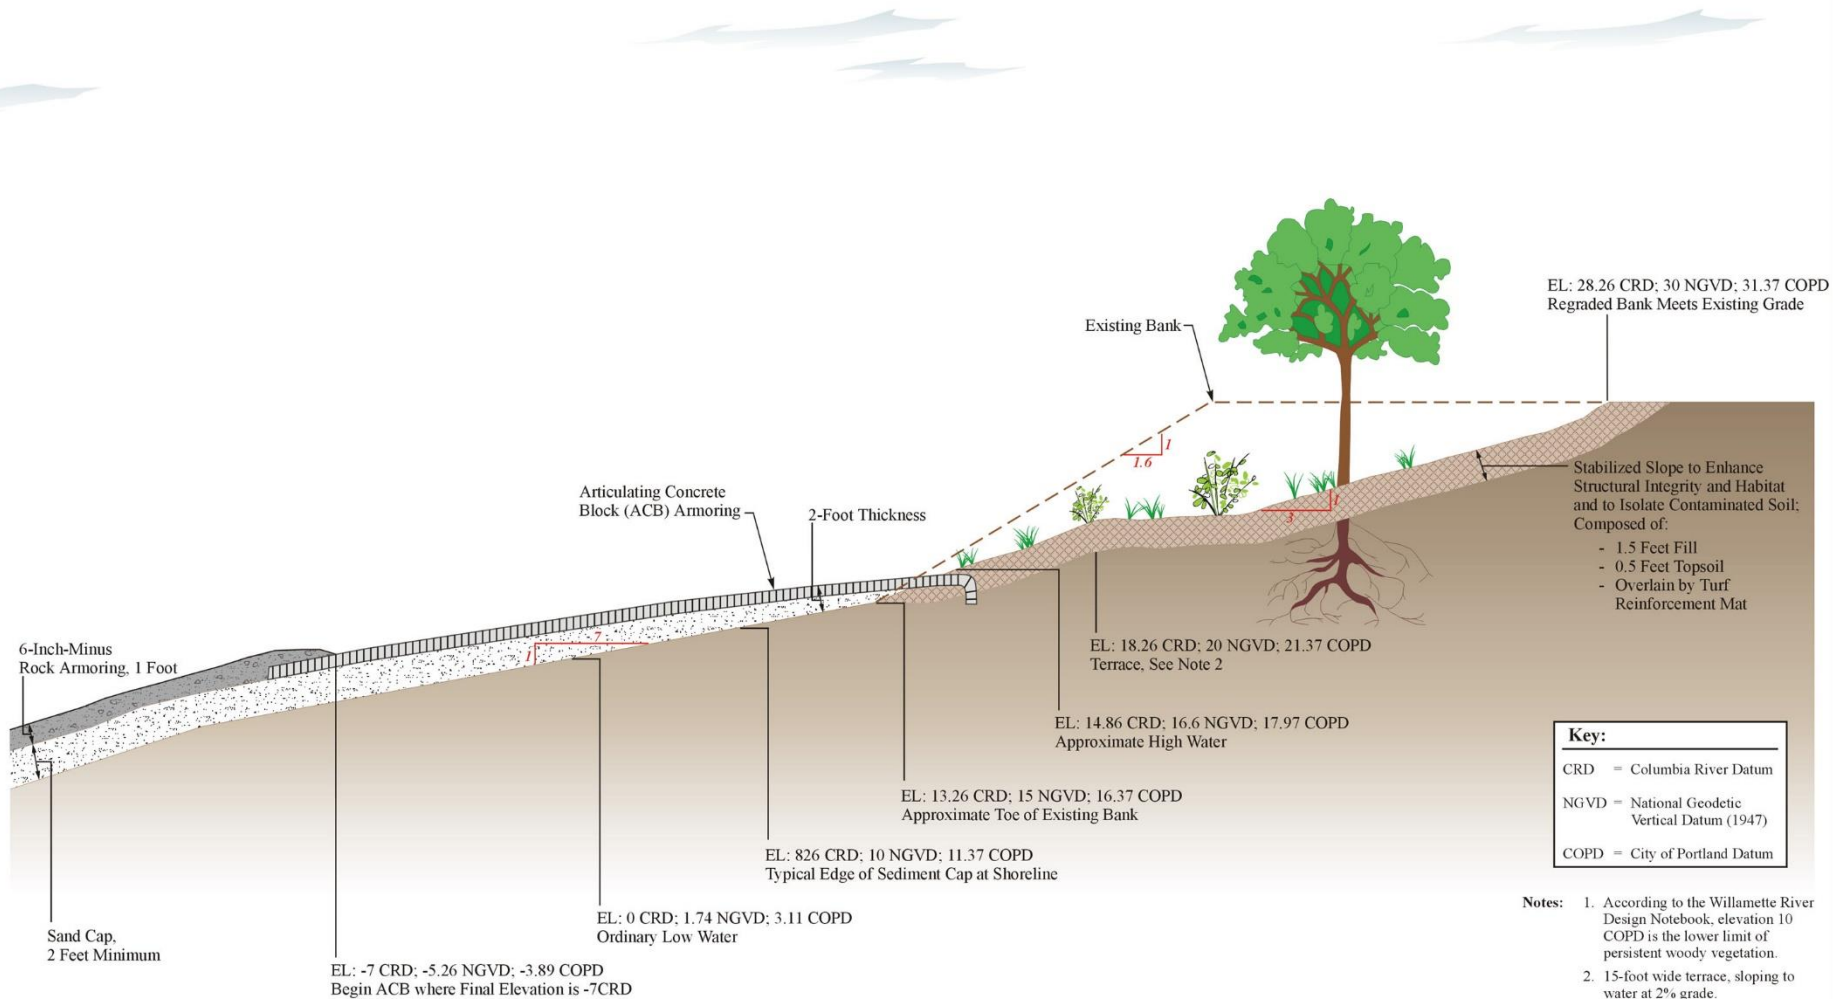
Figure 11  
CROSS-SECTION: UPLAND BANK

# River Bank Design Cross-Section

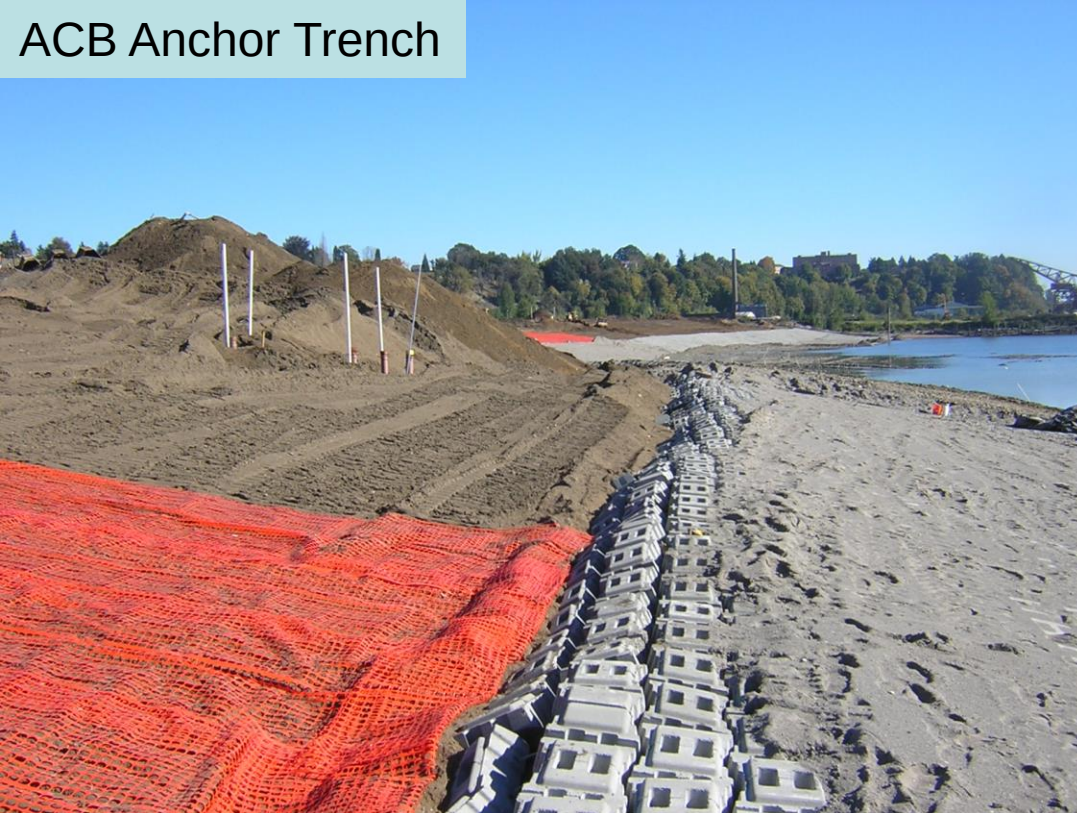
ACB Anchor Trench

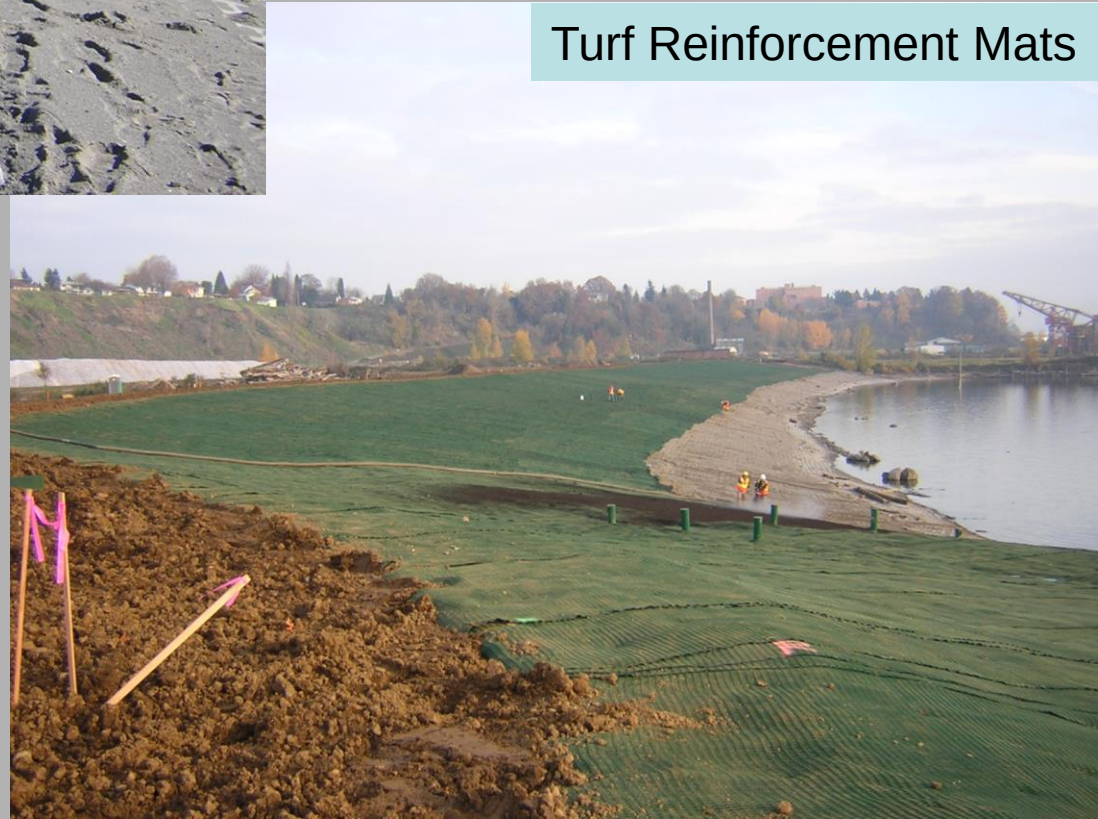
Turf Reinforcement Mats

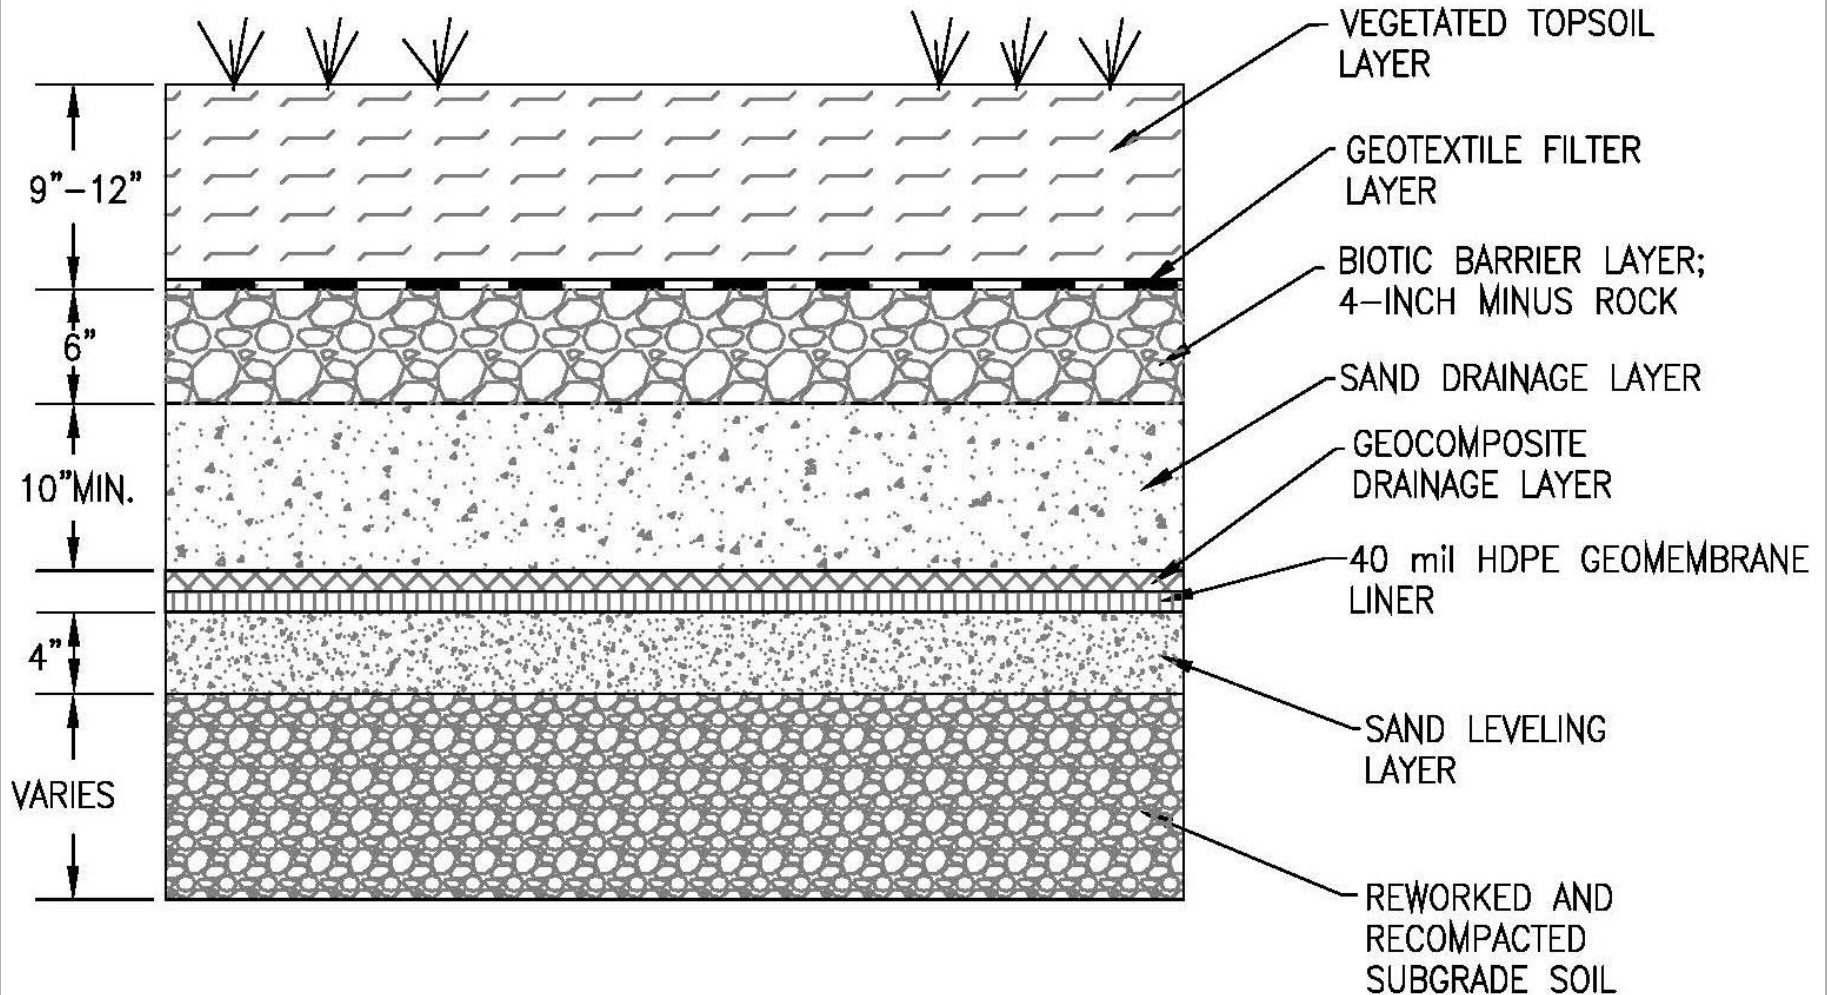
# Impermeable (Upland) Cap Design Cross-Section

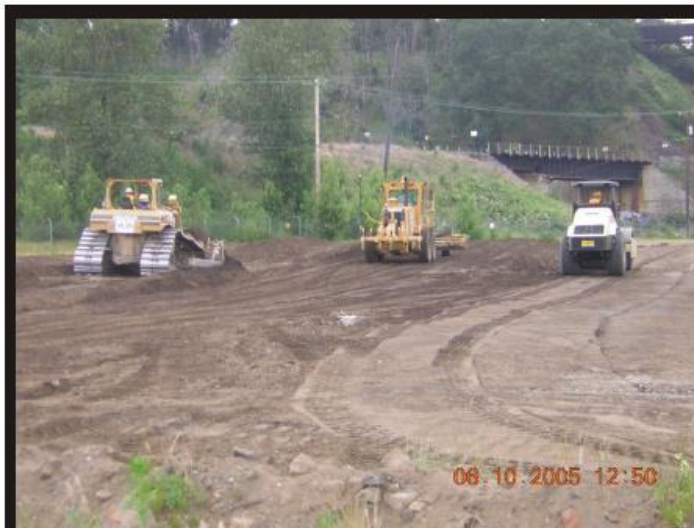
**Photo 1** Subgrade preparation along eastern edge of property.

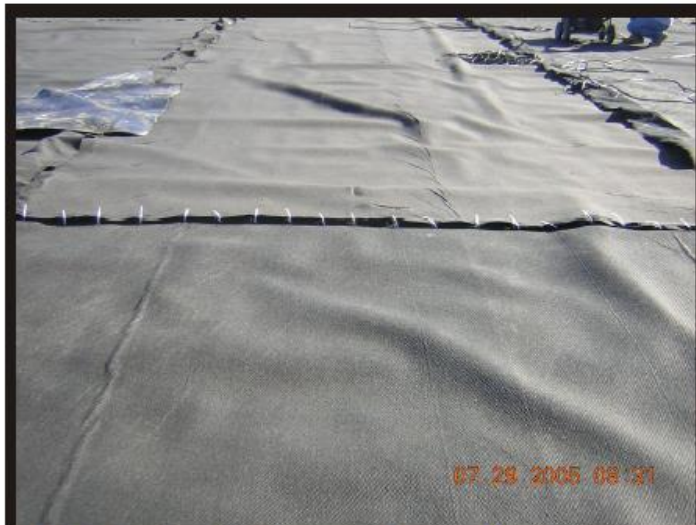
**Photo 30** Seams of geocomposite zip-tied together (left), and seams after they've been heat-tacked (right).

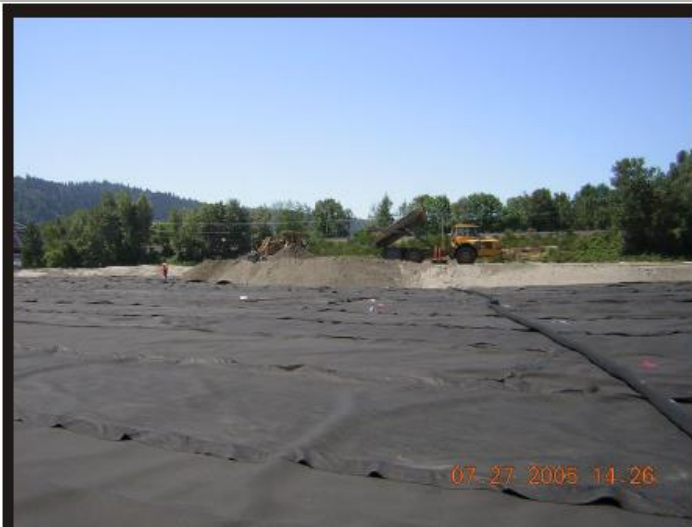
**Photo 32** Overview of site showing four layers of impermeable cap. Starting from the foreground: sand leveling layer, geomembrane layer, geocomposite layer, and drainage sand layer.

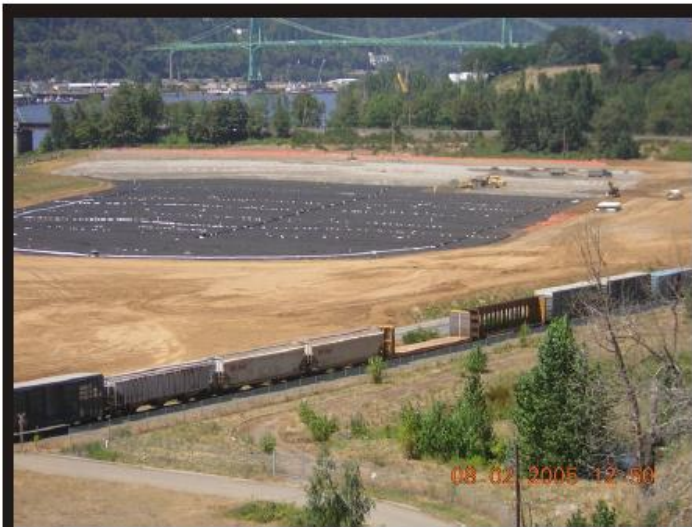
**Photo 34** Placement of 4" minus biotic rock.

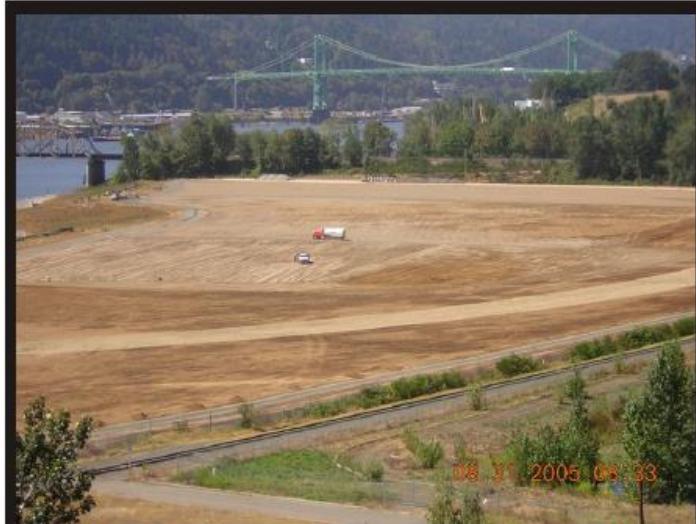
**Photo 40** Overview of site showing three layers of impermeable cap. Starting from the foreground: 4" minus biotic rock, geotextile, and topsoil.

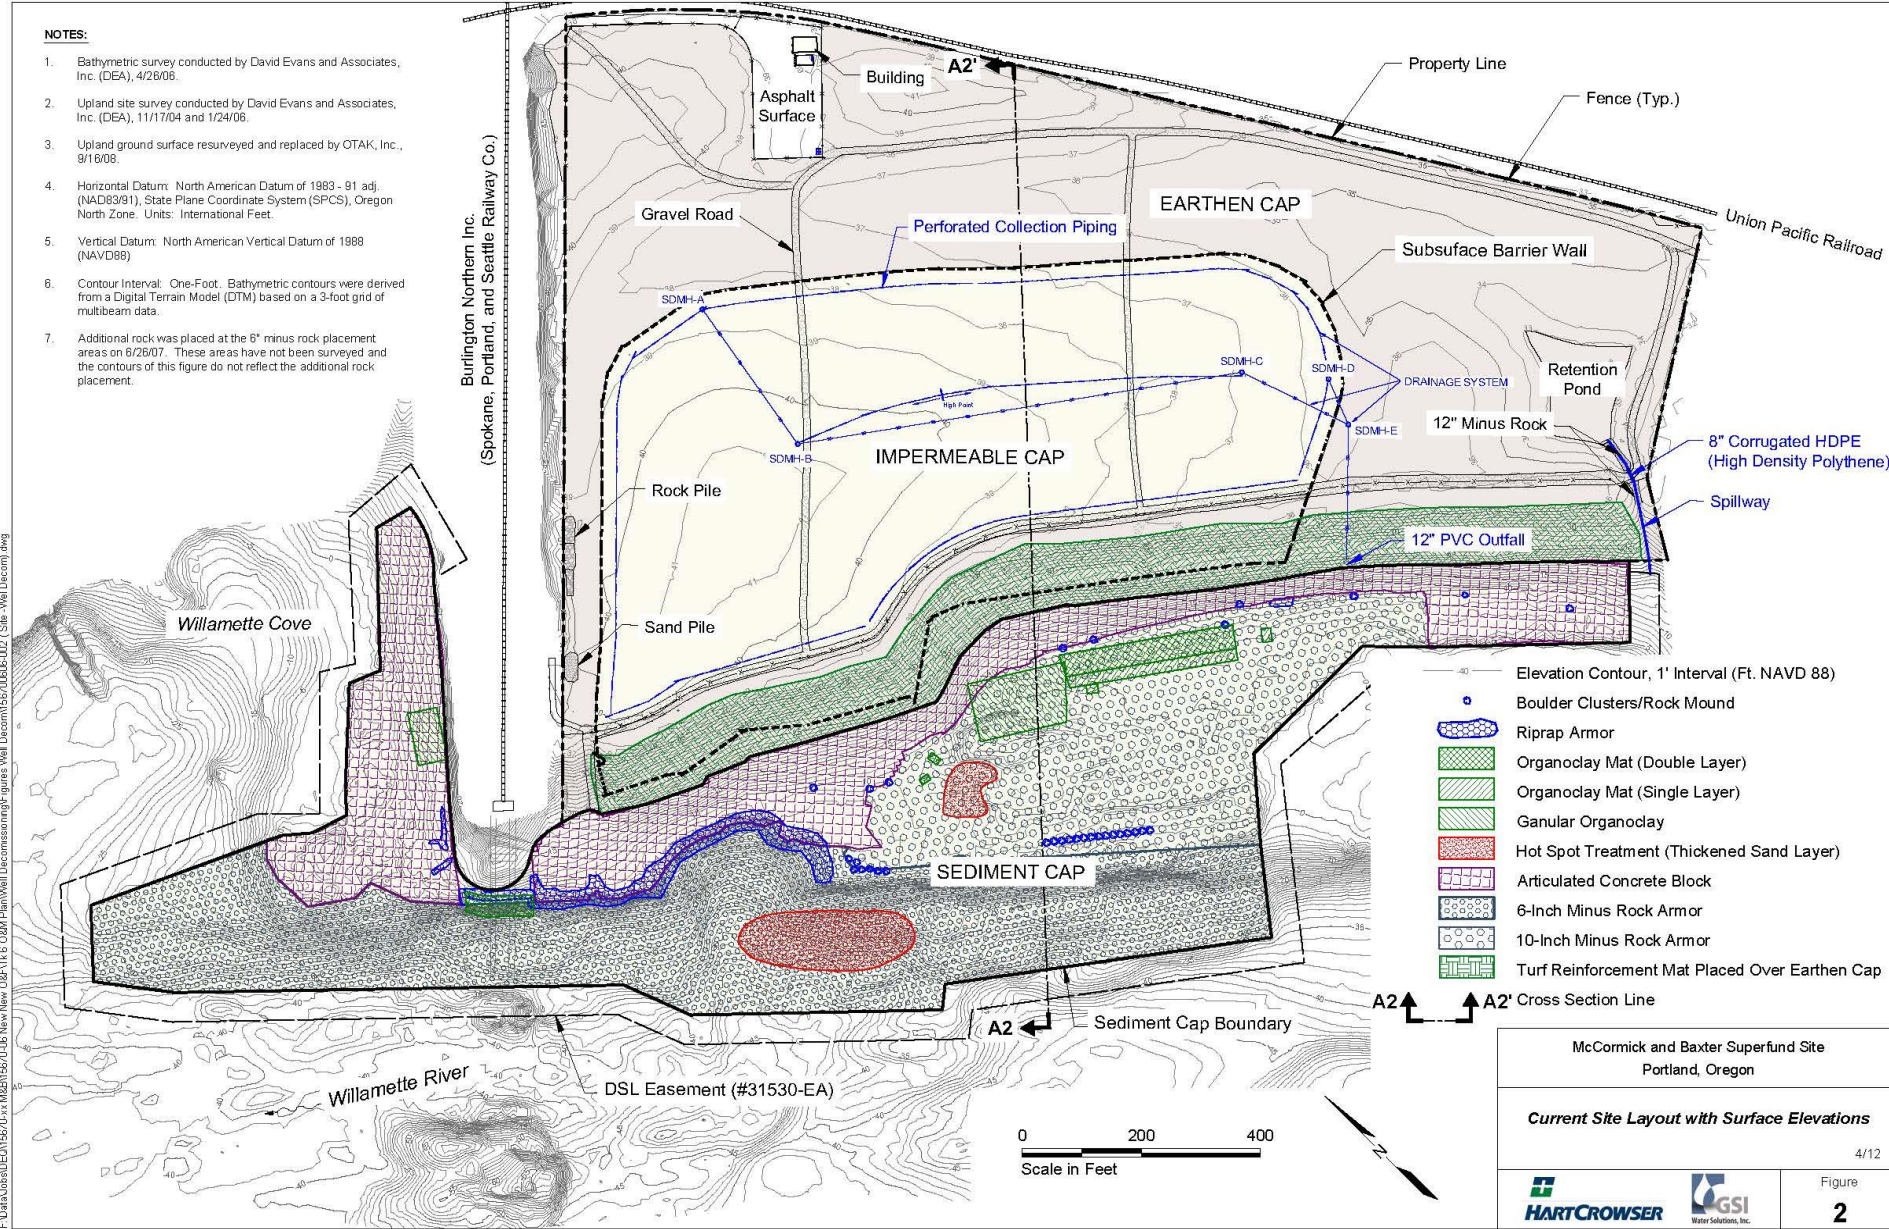
# Current Site Layout with Surface Elevations

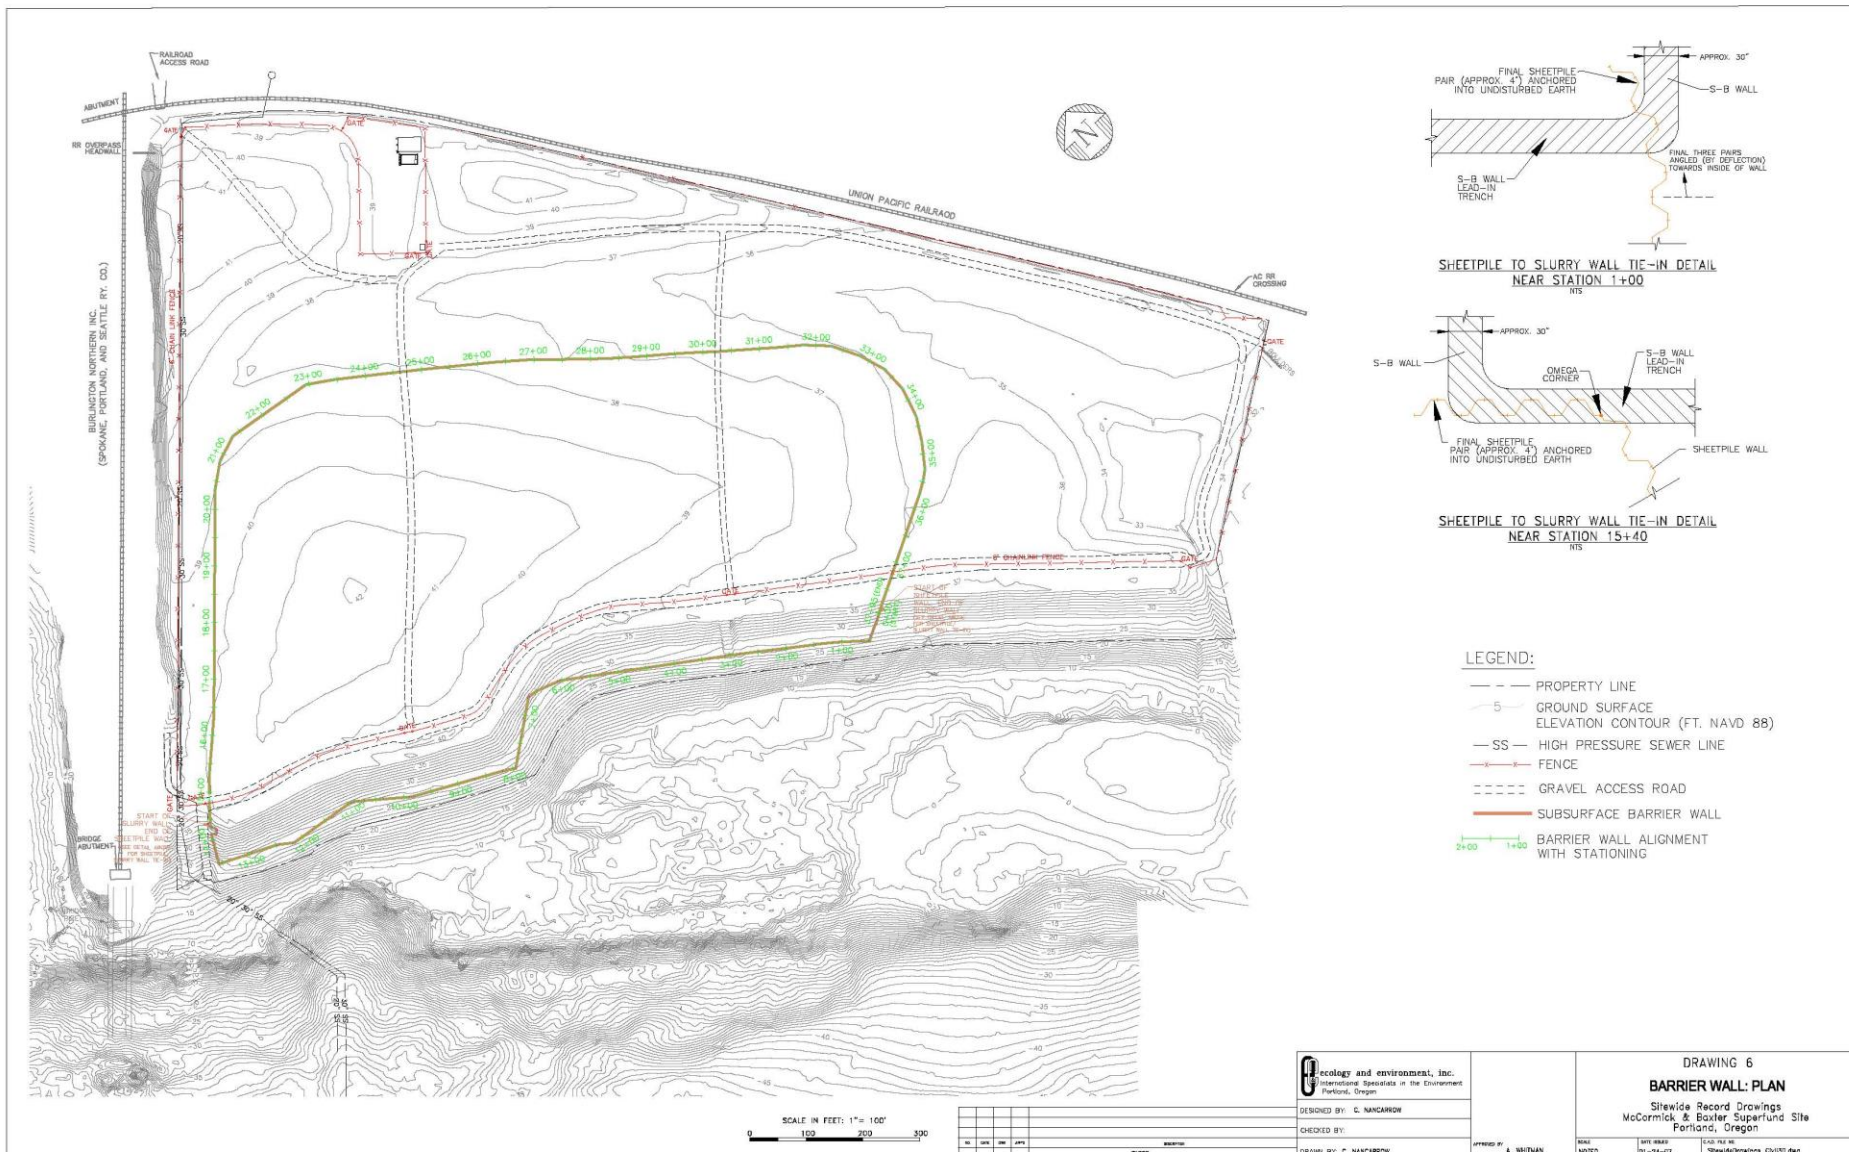
DRAWING 6

SHEETPILE TO SLURRY WALL TIE-IN DETAIL  
NEAR STATION 1+00

SHEETPILE TO SLURRY WALL TIE-IN DETAIL  
NEAR STATION 15+40

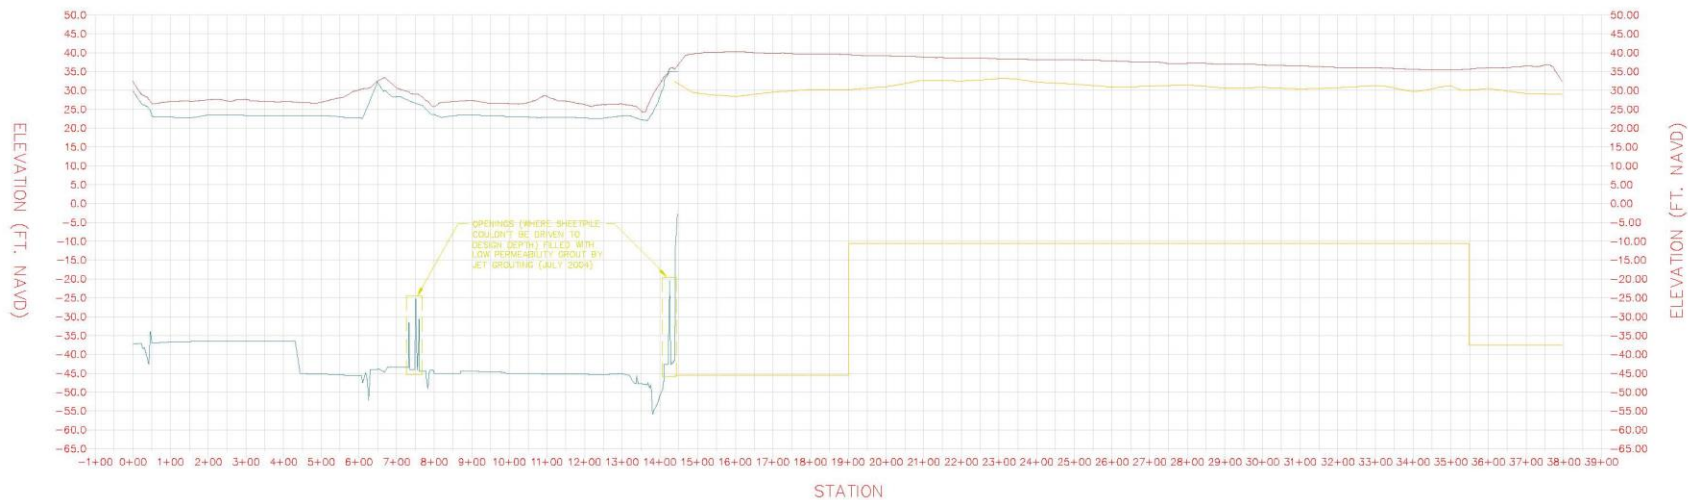
DRAWING 7  
**BARRIER WALL: PROFILE**  
Sitewide Record Drawings  
McCormick & Boxer Superfund Site  
Portland, Oregon

VERTICAL SCALE IN FEET: 1" = 15'  
(10X VERTICAL EXAGGERATION)

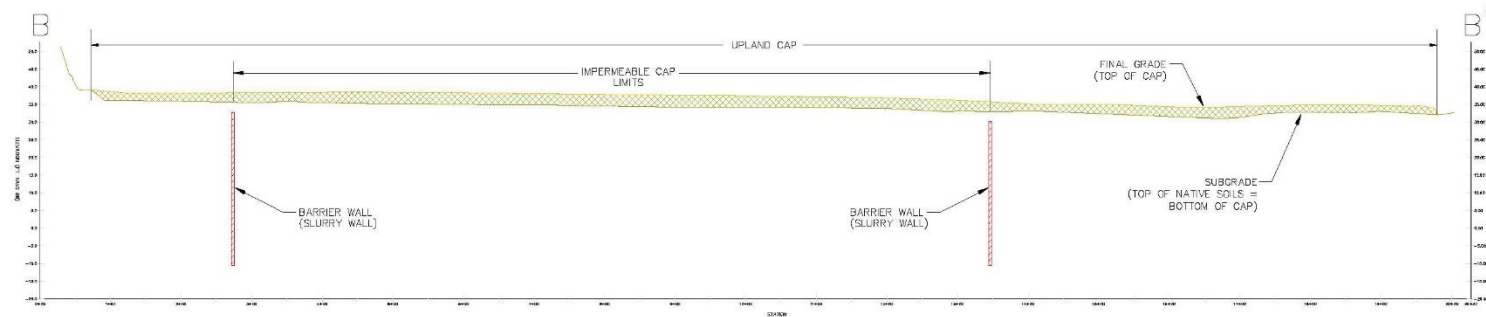
DRAWING 9

SECTIONS
